Cape Poge Breach – 1/5/11

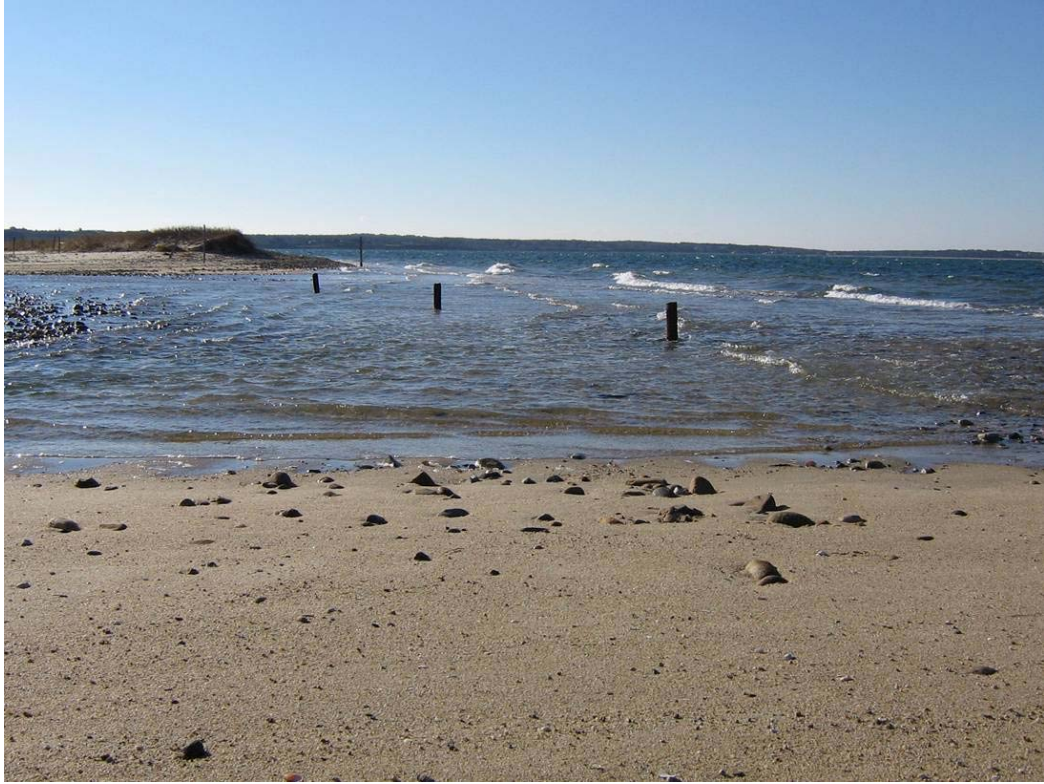
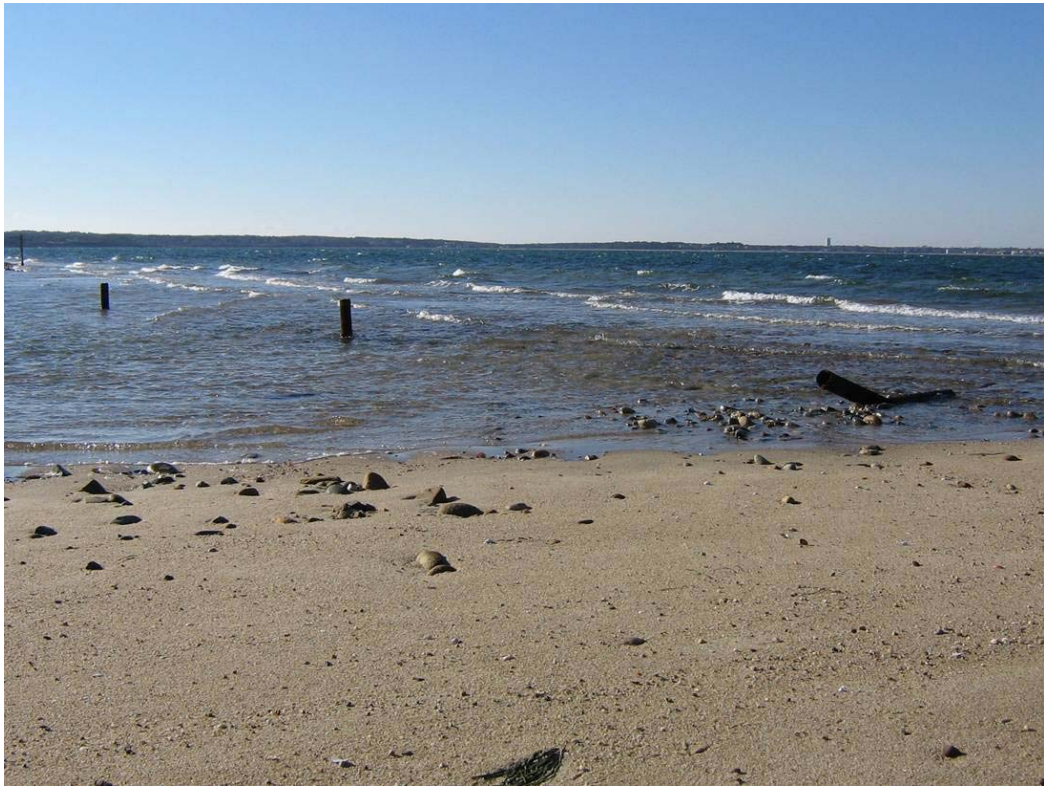
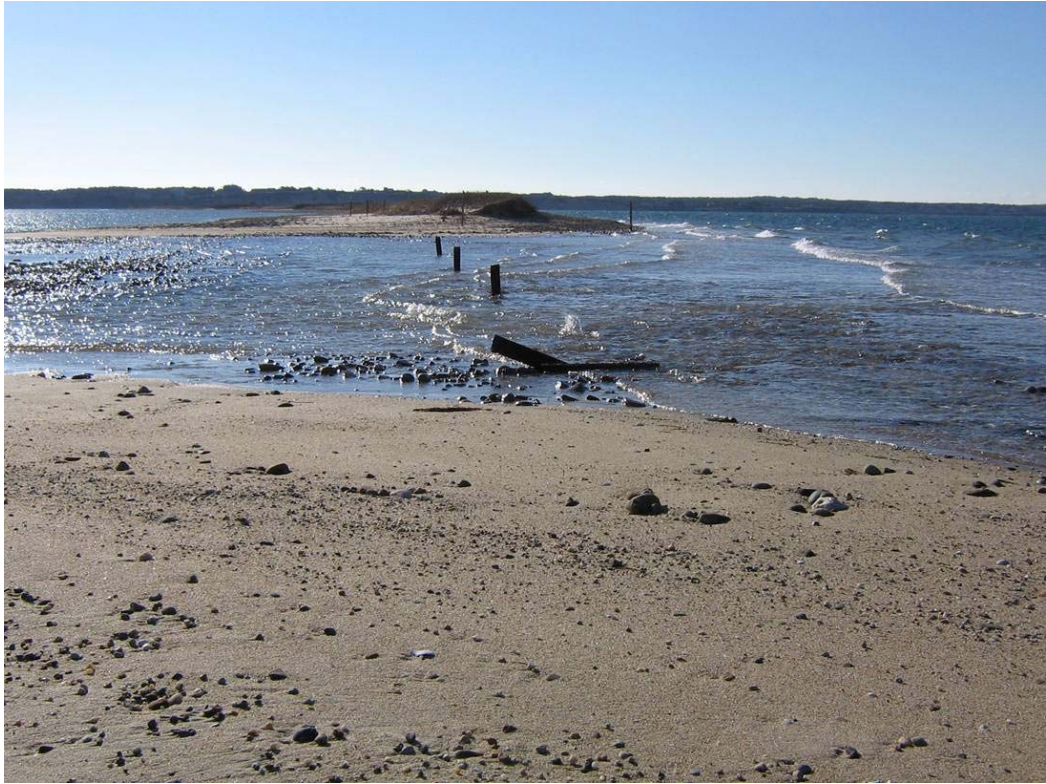
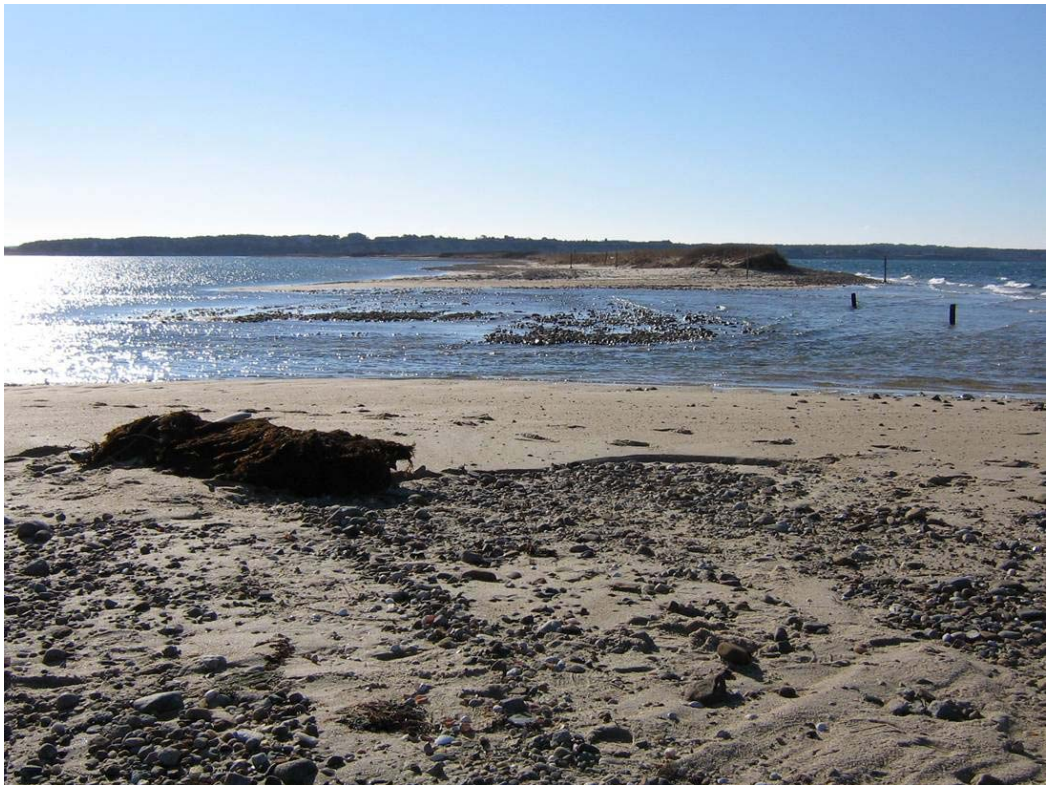
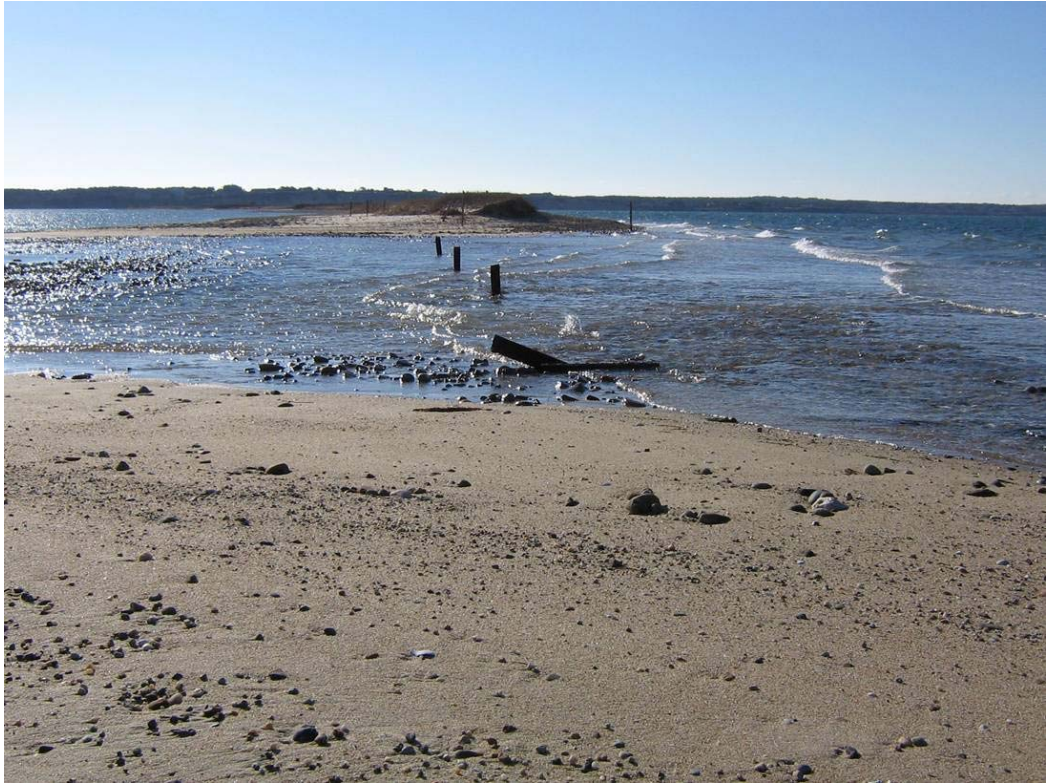
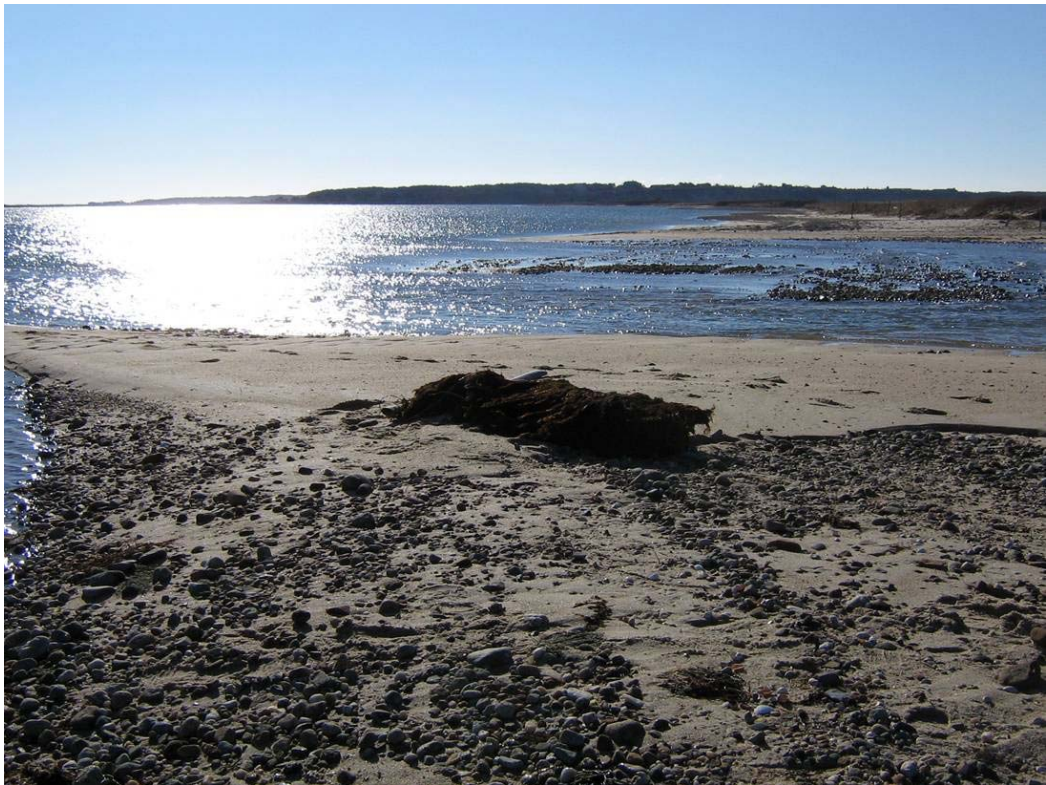
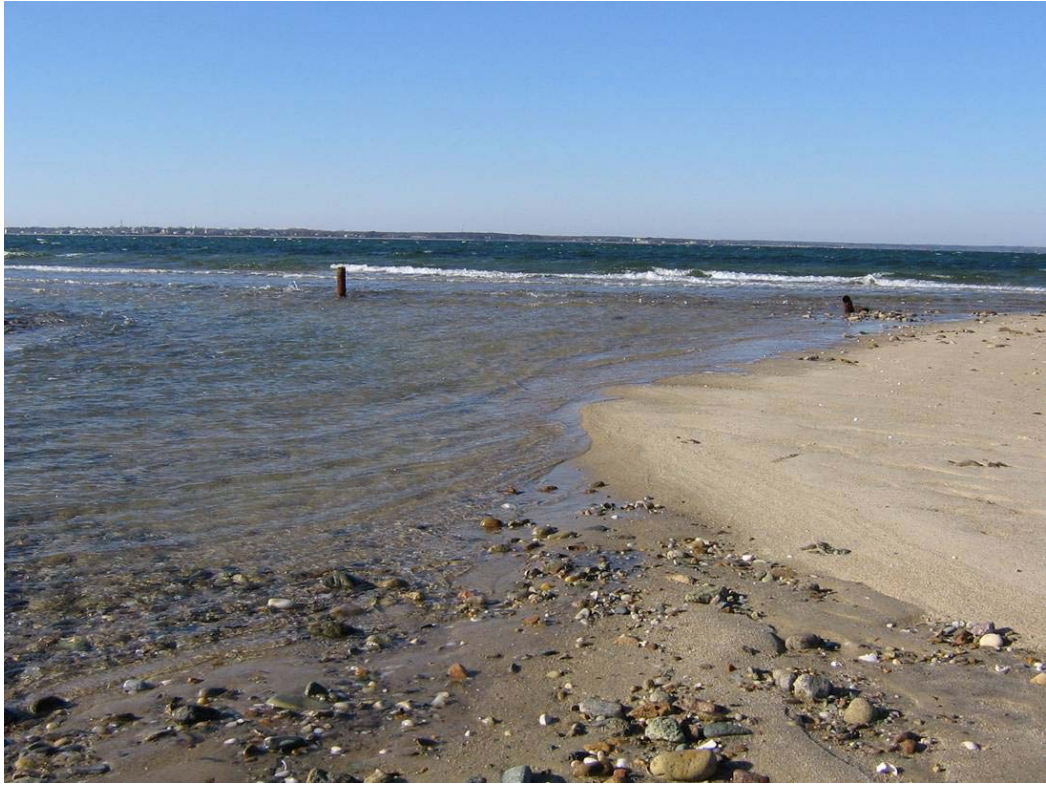
There is a new breach out on Cape Poge. It is between the windmill house and the Gut. The breach is located about 200 yards south of the windmill house and is approximately 100 feet wide and is about three feet deep at high tide. This makes it impassable even at low tide. Water is now flowing through the break between Edgartown Harbor and Cape Poge Bay.

Some interesting history on this story... the posts you see in the pictures below are the ones that everyone has been driving around for years. These posts were actually put in 30+ years ago to close the last breach. The locals drove the posts in and then strung used fishing nets to catch the sand and trap it to help close the breach. The breach then slowly filled back in and was eventually closed off.

In the photos, the windmill house would be behind you and to the right as you head south towards the Gut. If you were able to keep driving through the breach you would eventually reach the Gut with the stairs and boat house in front of you.

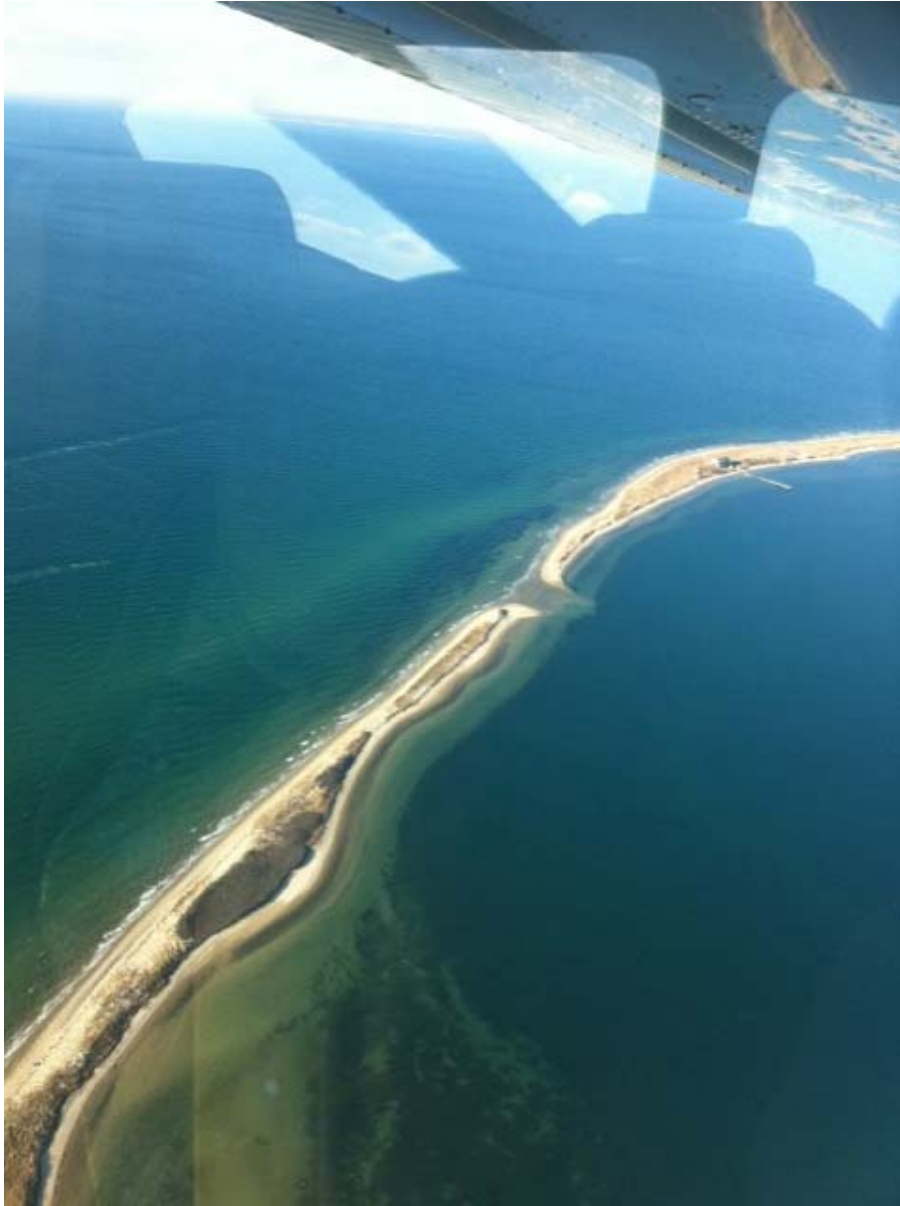
In addition to Peter's photos there is also an aerial view showing the Cape Poge breach.

In the aerial view, the shot is taken as if you were flying north from the Gut back toward the windmill house which would then be on your left. The windmill house in the aerial view is after the break in the top right hand corner of the picture.
